Riparian Restoration Plan for Turtle Bay East

City of Redding
Shasta County, California

February 22, 2012

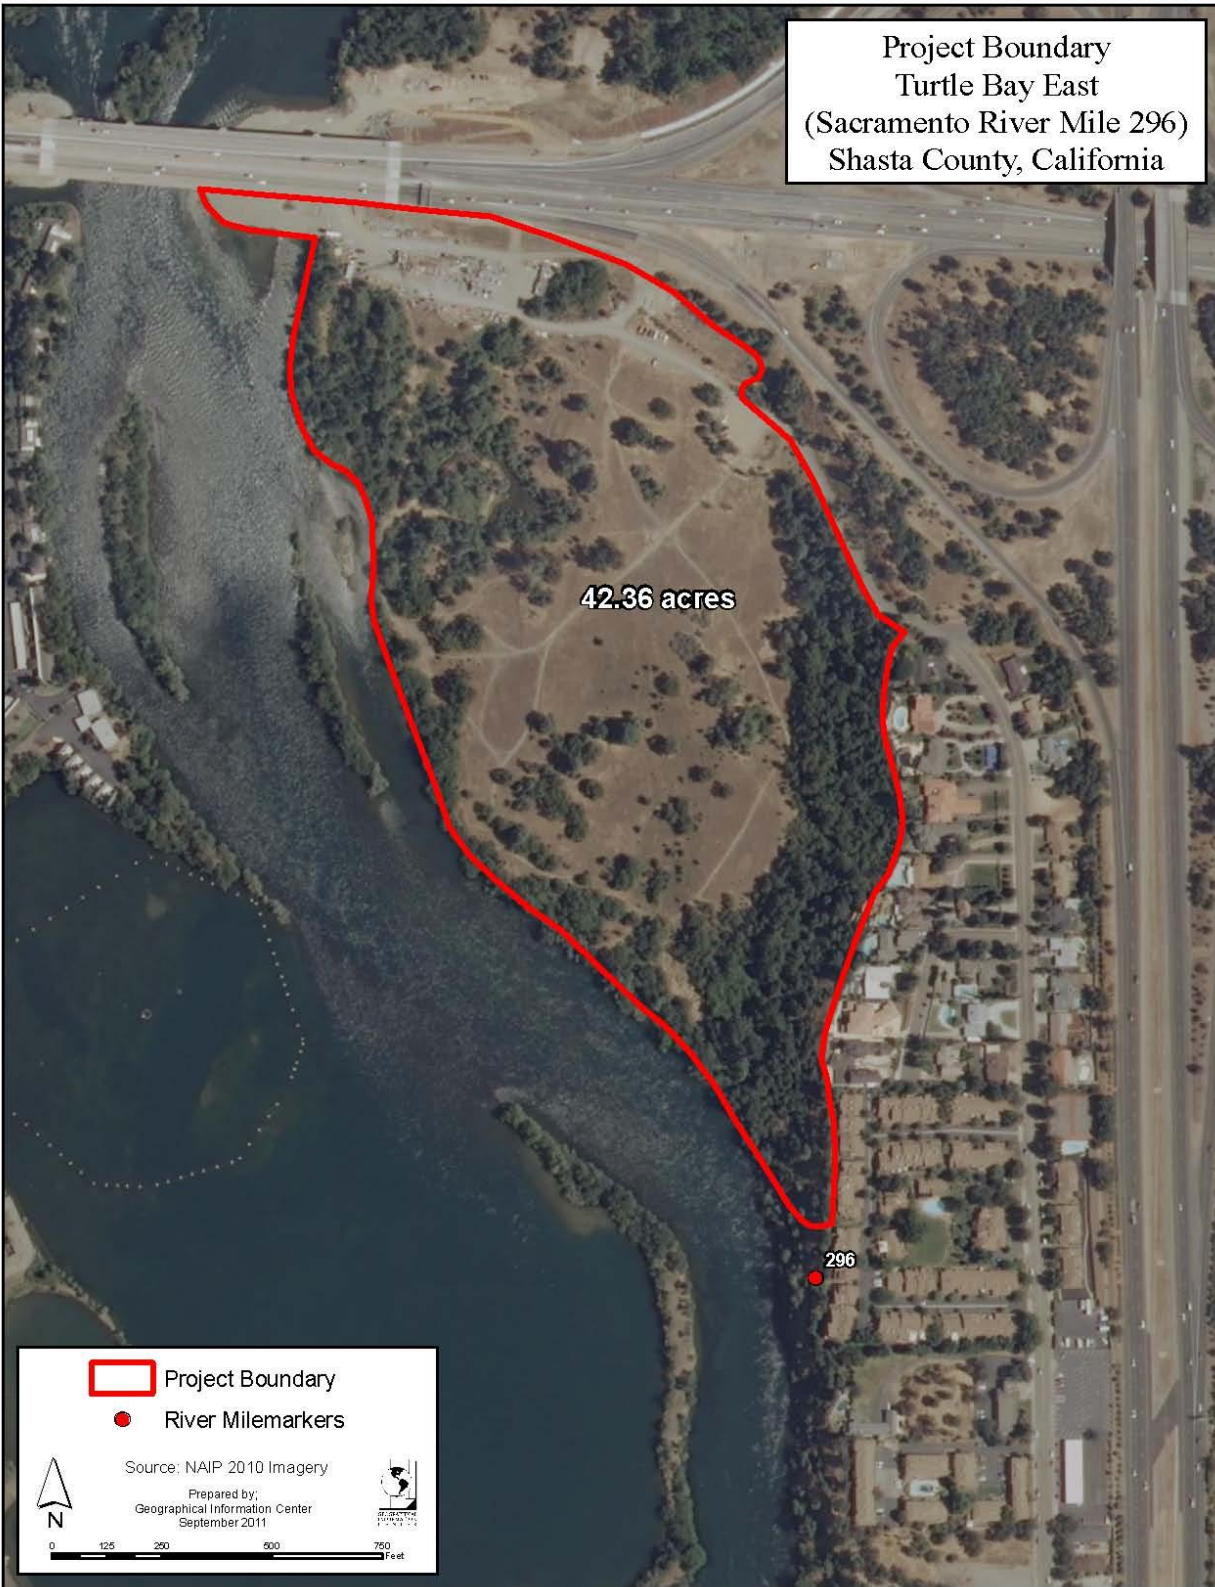
Figure 2. Project Boundary, Turtle Bay East, Shasta County, California.

The project site is the southernmost property in an area historically called Turtle Bay. The Turtle Bay area consists of the land, channels, and gravel bars at this large bend in the river. The project lies directly adjacent to the southwest corner of the Interstate 5 corridor and Highway 44 interchange. Turtle Bay East is a high-use public area abutting a large suburban community. This plan covers restoration and enhancement activities on a 42-acre parcel within Turtle Bay East (Figure 2).

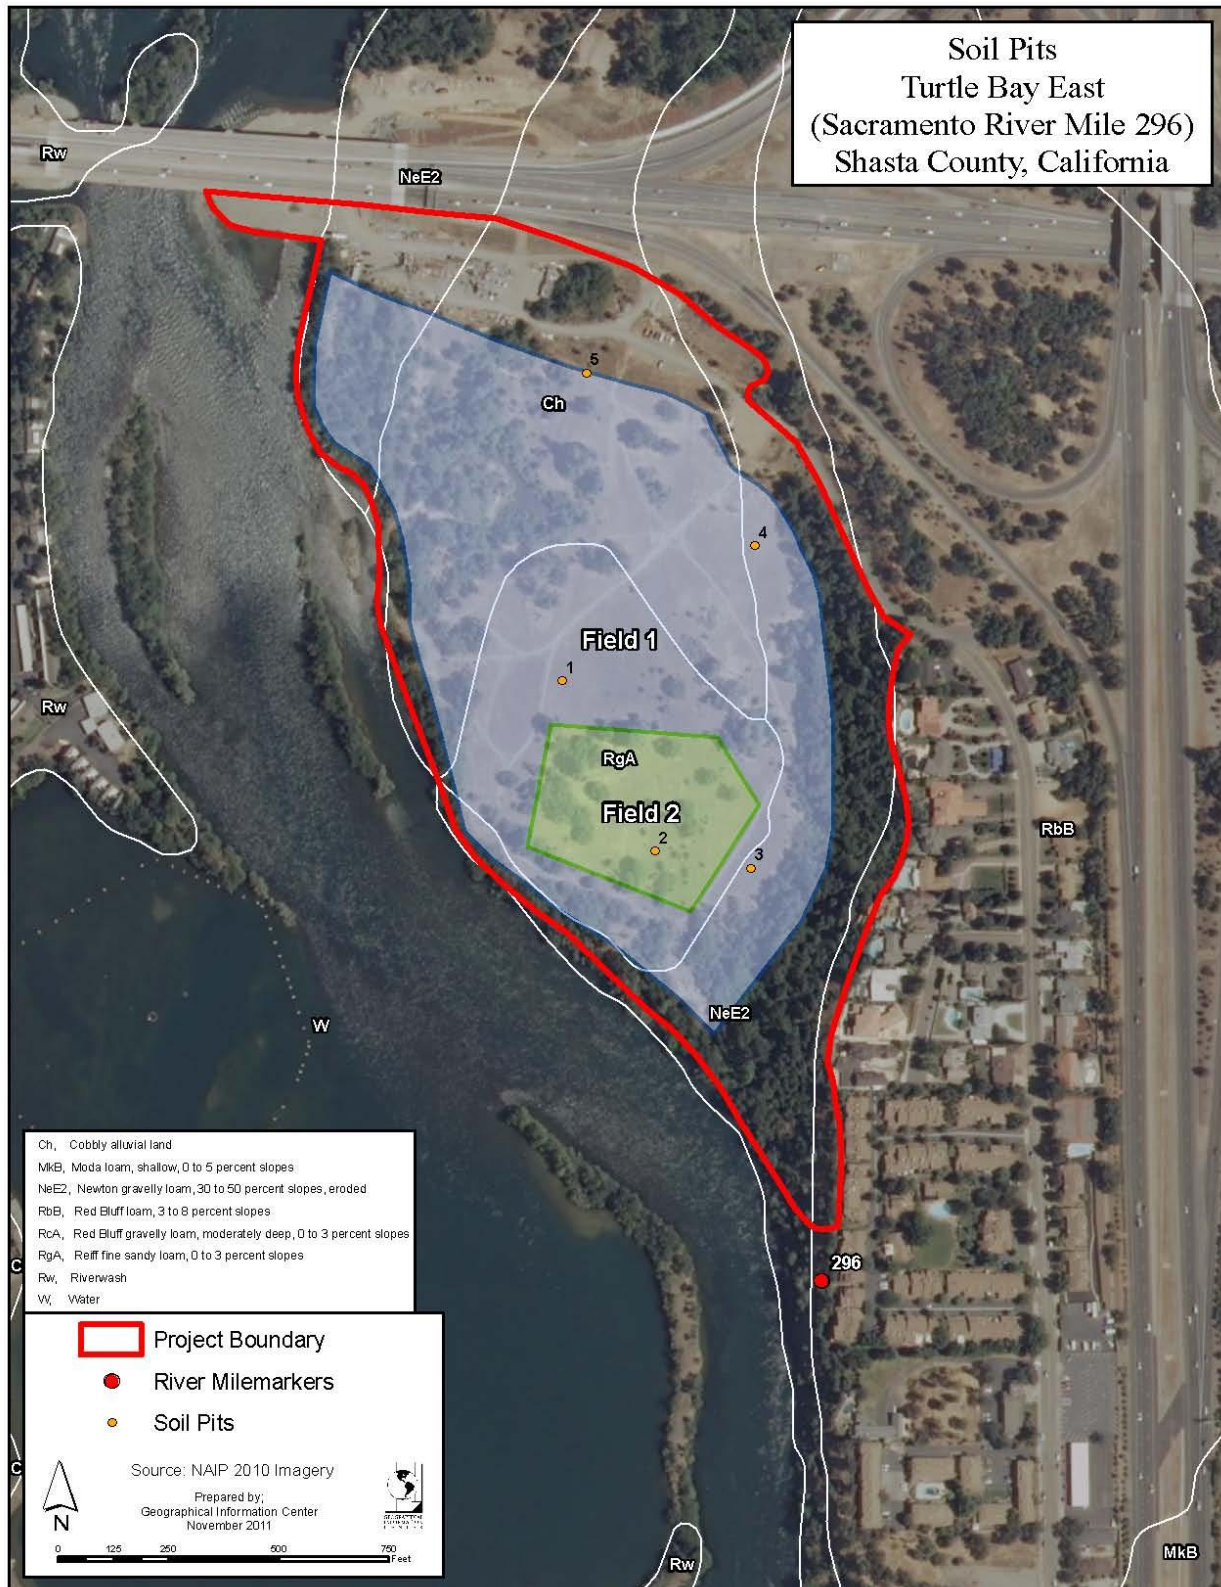
Figure 3. Soils Map, Turtle Bay East, Shasta County, California.

The Shasta County Soil Survey (Klaseen and Ellison 1974) identifies three soil series (Cobbly alluvial land, Newton gravelly loam, and Reiff fine sandy loam) for the site (Table 1 and Figure 3), but only the Reiff fine sandy loam is productive for riparian vegetation. The southern end of the site has developed a soil profile which is conducive for plant establishment and growth. The soil has a composition of over 80% cobbles, which makes planting and establishing plants across the majority of the site difficult.

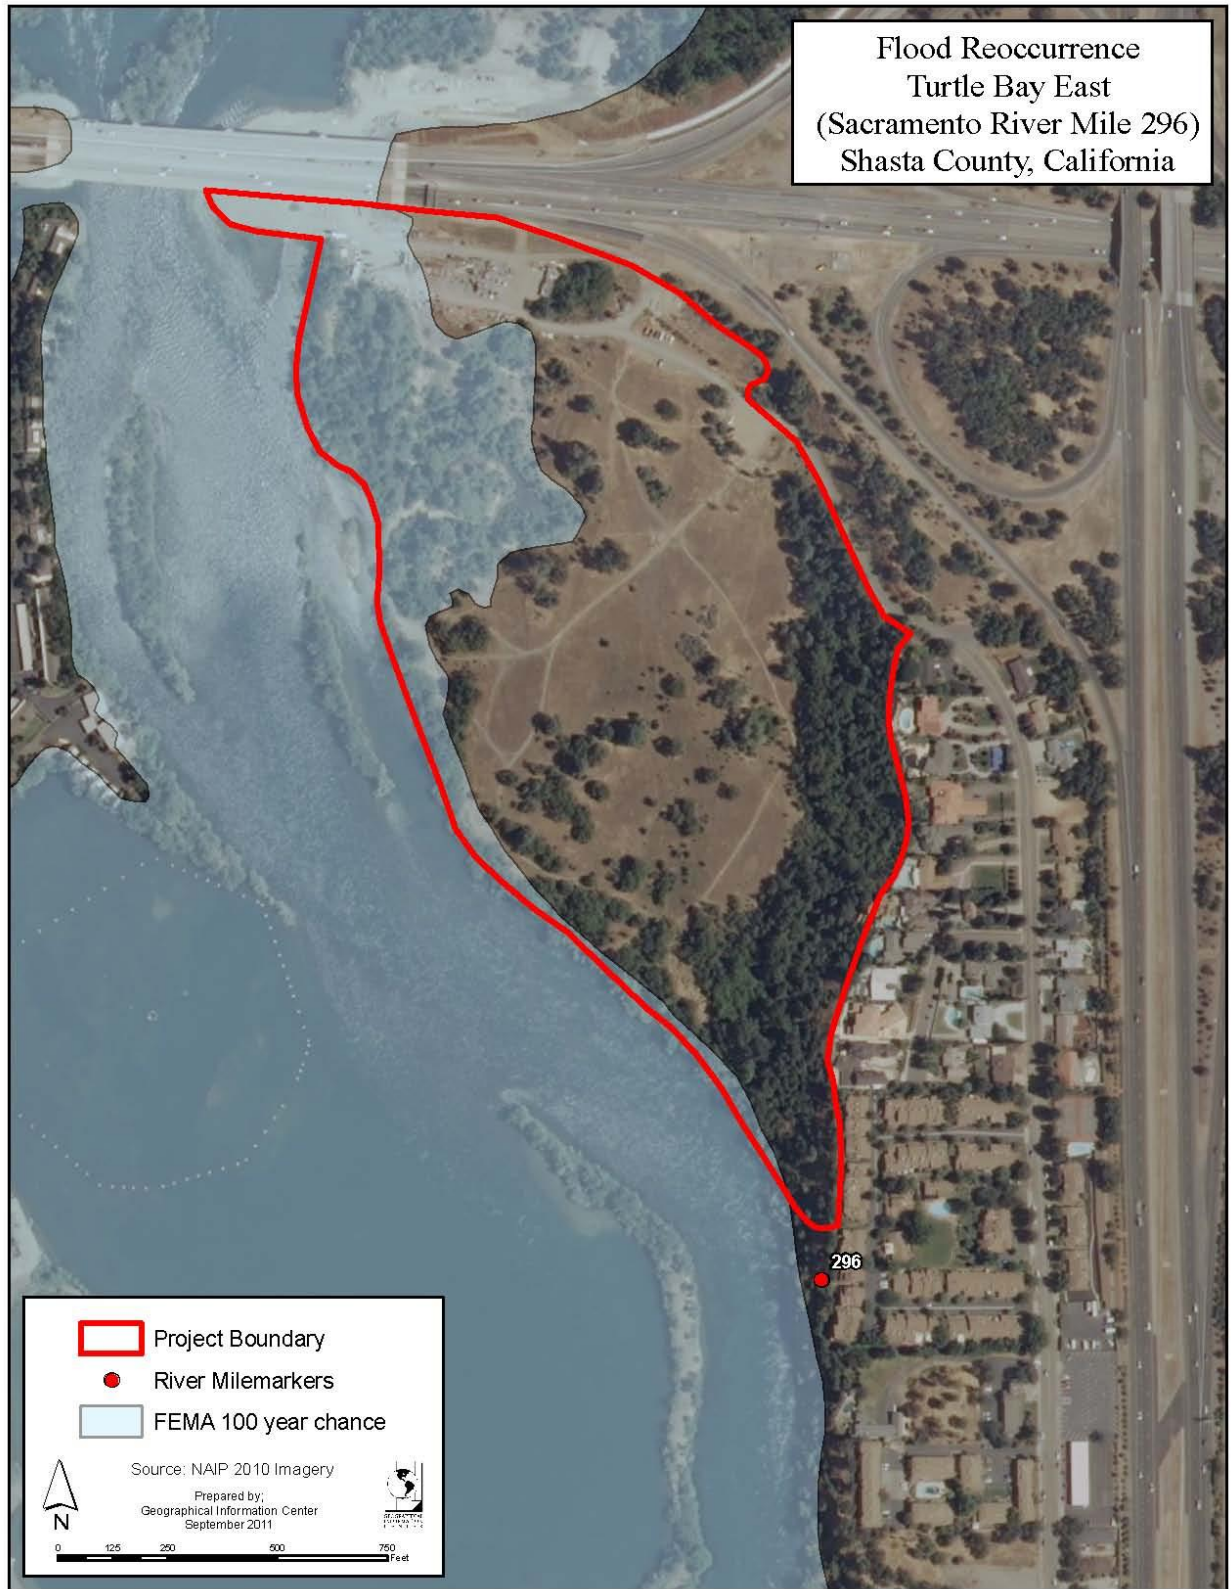
Figure 5. 100-Year Flood Zone Map, Turtle Bay East, Shasta County, California.

When water does inundate the site, it moves north to south along the northwestern edge of the property. It rushes through with high velocity, ripping vegetation and sending cobbles and sediment into the river. The property floods when Bureau of Reclamation needs to make room for anticipated releases from Shasta Dam. These higher releases are very infrequent and of short duration. The last maximum controlled release, or 100-year flood, occurred in 1997, and was 79,000 cubic feet per second (cfs) (Terry Hanson, personal communication). The remainder of the property sits at an elevation above that of these flows.

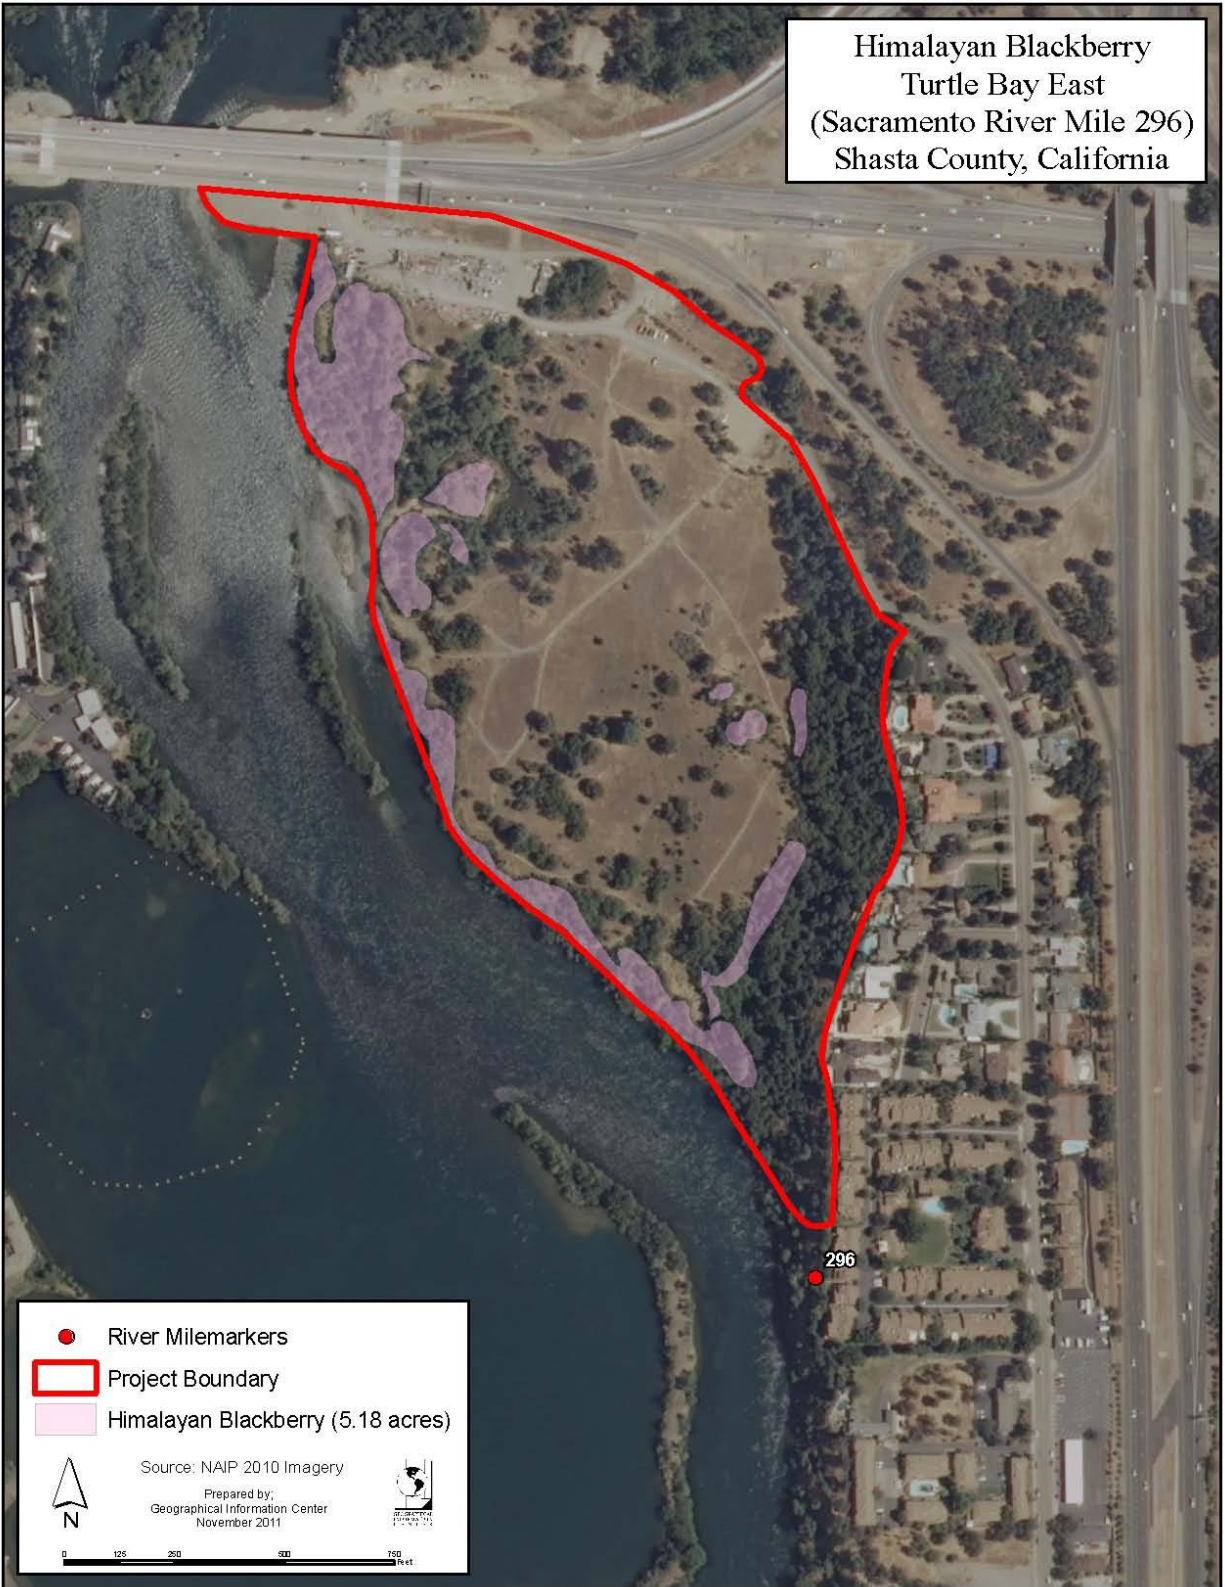
Figure 9. Himalayan Blackberry Extent, Turtle Bay East, Shasta County, California.

Targeted species include tree-of-heaven, Scotch broom, yellow star-thistle, black locust, Scotch broom, and Himalayan blackberry (Figure 9). Enhancement activities will occur on approximately 38 acres, including much of Field 1. The primary focus of the Enhancement Area is to target non-native invasive species removal (Figure 10). Primary management methods for this area will be a combination of mowing and herbicide application of Garlon3®, Round-up®, and Goal® to all non-native species including trees, shrubs, forbs, and grasses. Following this treatment, the invasive trees and shrubs will be removed by hand or by using field equipment if site conditions permit. The equipment is owned by the City of Redding, and River Partners will consult with Terry Hanson, City of Redding, during the site preparation phase to determine the best mechanical method for extraction. Following weed removal, native blackberry will be installed to take the place of the removed vegetation.
